# Access Compliance Report Public Rights-of-Way (Pedestrian Signals)

Main Street: CRAWFORD\_CANYON\_RD Cross Street: CHAPMAN\_AVE Location: SW

ADA ID: SGRK211007170548 Signal Type: One Push Button-Non APS Overall Compliance: No Severity Scores: BTN 1: 10 BTN 2: N/A No BTN: N/A

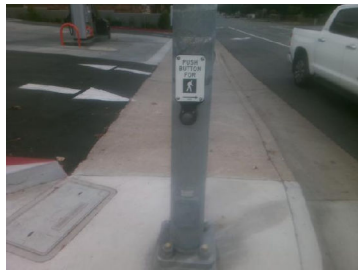
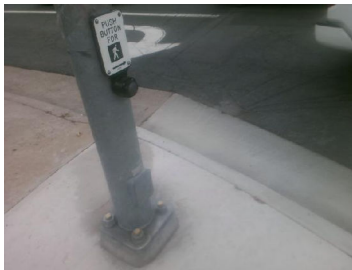
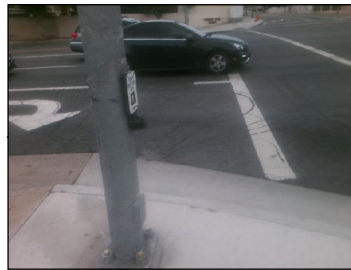
| No B 1 Pilot Light? | No | N/A B 2 Pilot Light? | N/A |

Possible Solutions: Replace Signal Push Button With APS Button.
