# Access Compliance Report Public Rights-of-Way (Pedestrian Signals)

Main Street: CRAWFORD\_CANYON\_RD Cross Street: CHAPMAN\_AVE Location: SW

ADA ID: SGRK211007170745 Signal Type: One Push Button-Non APS Overall Compliance: No Severity Scores: BTN 1: 35 BTN 2: N/A No BTN: N/A

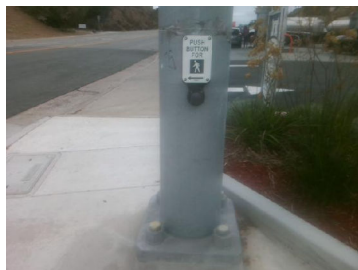
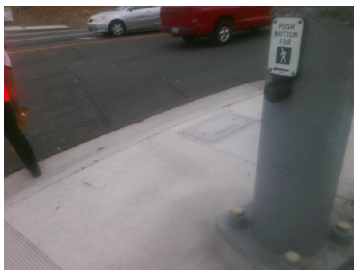
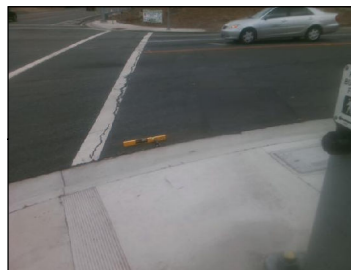
| Compliance | Description | Data | Compliance | Description | Data |
|---|---|---|---|---|---|
| No B 1 Clear Floor Space Slope (%) | | 3.8 | N/A | B 2 Clear Floor Space Slope (%) | N/A |
| No B 1 Clear Floor Space XSlope (%) | | 2.5 | N/A | B 2 Clear Floor Space XSlope (%) | N/A |
| No B 1 DistanceTo XWalk (in) | | 64 | N/A | B 2 DistanceTo XWalk (in) | N/A |

Possible Solutions: Replace Signal Push Button With APS Button. Remove & Relocate Sign.

OC Std/PROW: MUTCD 4e.08, R404.2, R404.3
