# Access Compliance Report Public Rights-of-Way (Pedestrian Signals)

Main Street: **CRAWFORD\_CANYON\_RD** Cross Street: **CHAPMAN\_AVE** Location: **SE**

ADA ID: **SGRK211007171204** Signal Type: **One Push Button-Non APS** Overall Compliance: **No** Severity Scores: **BTN 1: 10** **BTN 2: N/A** **No BTN: N/A**

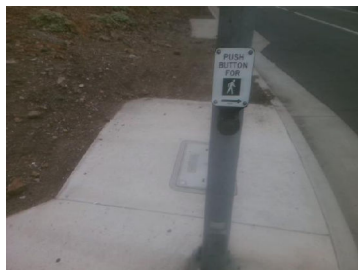
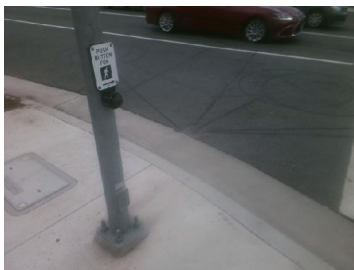
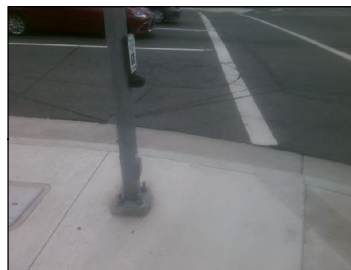
| <b>No</b> B 1 Pilot Light? | <b>No</b> | <b>N/A</b> B 2 Pilot Light? | <b>N/A</b> |

Possible Solutions: Replace Signal Push Button With APS Button.

Total Cost: \$ **900**
