# Access Compliance Report Public Rights-of-Way (Pedestrian Signals)

Main Street: CRAWFORD\_CANYON\_RD Cross Street: CHAPMAN\_AVE Location: SE

ADA ID: SGRK211007171405 Signal Type: One Push Button-Non APS Overall Compliance: No Severity Scores: BTN 1: 35 BTN 2: N/A No BTN: N/A

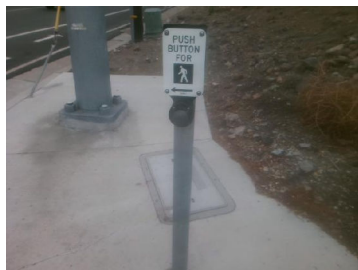
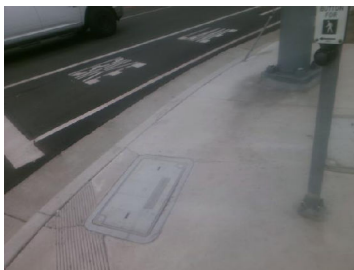
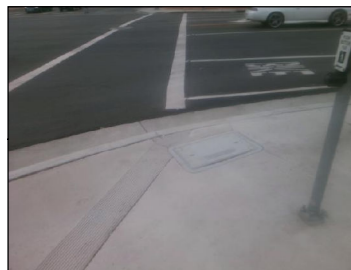
| Compliance | Description | Data | Compliance | Description | Data |
|---|---|---|---|---|---|
| No B 1 Clear Floor Space Slope (%) | 5 | N/A | B 2 Clear Floor Space Slope (%) | N/A | |
| No B 1 Clear Floor Space XSlope (%) | 8.6 | N/A | B 2 Clear Floor Space XSlope (%) | N/A | |

Possible Solutions: Replace Signal Push Button With APS Button. Remove and Replace Clear Space.
