# Access Compliance Report Public Rights-of-Way (Pedestrian Signals)

Main Street: CRAWFORD\_CANYON\_RD Cross Street: BARRETT\_LN Location: N

ADA ID: SGRK211007175056 Signal Type: One Push Button-APS Overall Compliance: No Severity Scores: BTN 1: 35 BTN 2: N/A No BTN: N/A

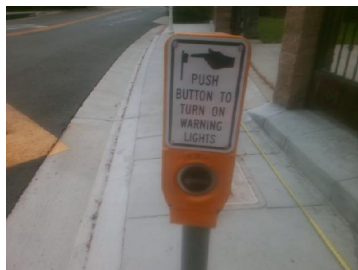
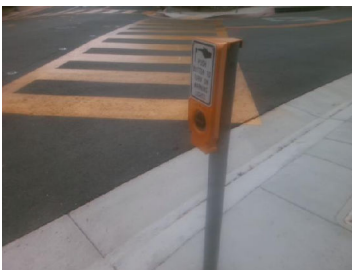
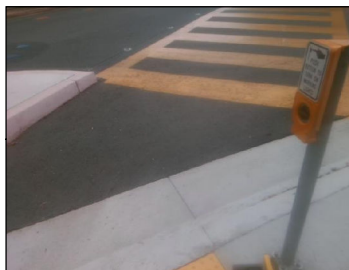
| Compliance | Description | Data | Compliance | Description | Data |
|---|---|---|---|---|---|
| No | B 1 Parallel To XWalk? | No | N/A | B 2 Parallel To XWalk? | N/A |
| No | B 1 Clear Floor Space Slope (%) | 7.2 | N/A | B 2 Clear Floor Space Slope (%) | N/A |
| No | B 1 Clear Floor Space XSlope (%) | 5.7 | N/A | B 2 Clear Floor Space XSlope (%) | N/A |
| No | B 1 DistanceTo Curb (in) | 16 | N/A | B 2 DistanceTo Curb (in) | N/A |

Possible Solutions: Replace Signal Push Button With APS Button. Remove & Relocate Sign.

OC Std/PROW: R209.1, MUTCD 4e.08, R404.2, R404.3
