# Access Compliance Report Public Rights-of-Way (Pedestrian Signals)

Main Street: CRAWFORD\_CANYON\_RD Cross Street: BARRETT\_LN Location: S

ADA ID: SGRK211007175546 Signal Type: One Push Button-APS Overall Compliance: No Severity Scores: BTN 1: 25 BTN 2: N/A No BTN: N/A

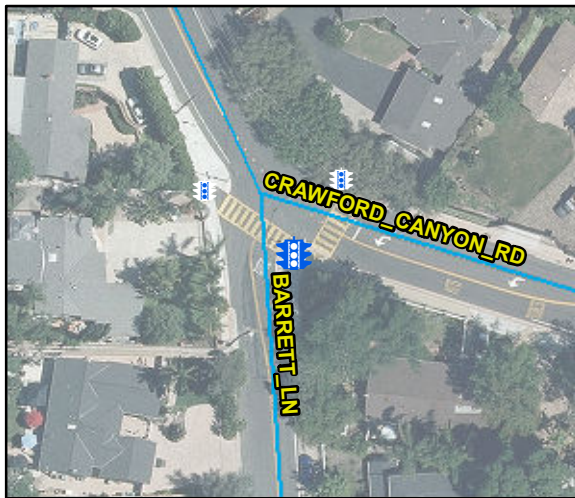
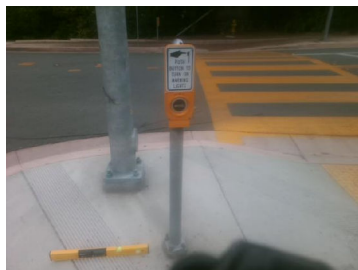
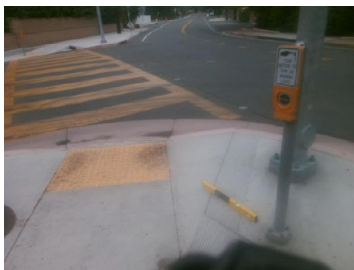
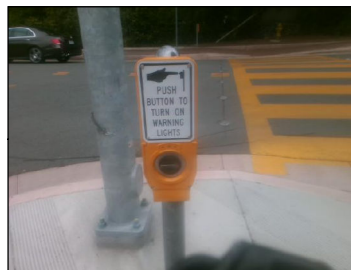
| Compliance | Description | Data | Compliance | Description | Data |
|---|---|---|---|---|---|
| Yes | B 1 Clear Floor Space Slope (%) | 2.4 | N/A | B 2 Clear Floor Space Slope (%) | N/A |
| No | B 1 Clear Floor Space XSlope (%) | 5.7 | N/A | B 2 Clear Floor Space XSlope (%) | N/A |

Possible Solutions: Remove and Replace Clear Space.

OC Std/PROW: R404.2

Total Cost: \$ 378
