# Access Compliance Report Public Rights-of-Way (Pedestrian Signals)

Main Street: CRAWFORD\_CANYON\_RD Cross Street: CRAWFORD\_CANYON\_RD Location: E

ADA ID: SGRK211007180222 Signal Type: One Push Button-APS Overall Compliance: No Severity Scores: BTN 1: 25 BTN 2: N/A No BTN: N/A

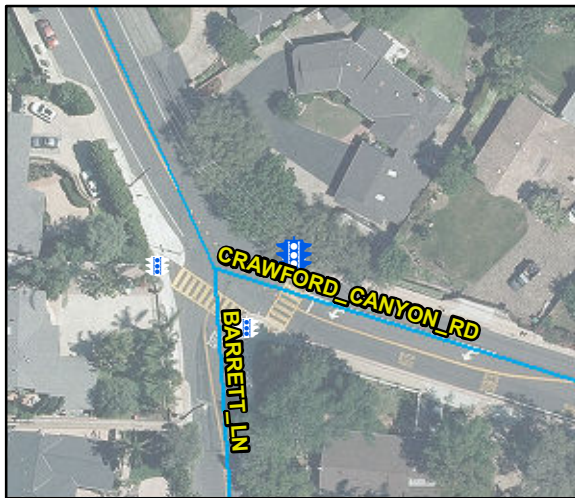
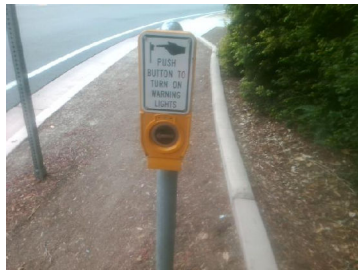
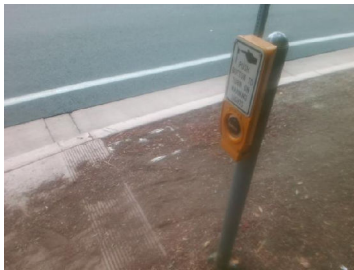
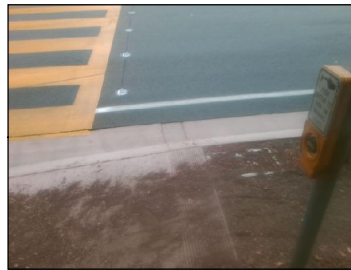
| Compliance | Description | Data | Compliance | Description | Data |
|---|---|---|---|---|---|
| No | B 1 Clear Floor Space XSlope (%) | 12.3 | N/A | B 2 Clear Floor Space XSlope (%) | N/A |

Possible Solutions: Remove and Replace Clear Space.

OC Std/PROW: R404.2

Total Cost: \$ 378
