# Access Compliance Report Public Rights-of-Way (Pedestrian Signals)

Main Street: HEWES\_AVE Cross Street: 17TH\_ST Location: NE

ADA ID: SGRK211008122640 Signal Type: One Push Button-Non APS Overall Compliance: No Severity Scores: BTN 1: 45 BTN 2: N/A No BTN: N/A

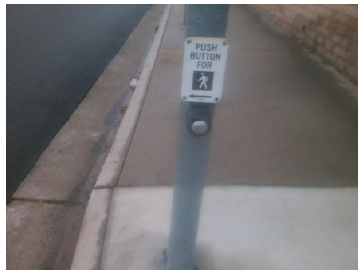
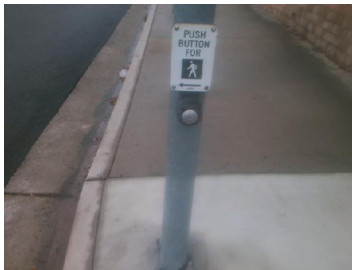
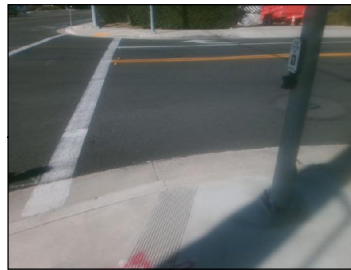
| Compliance | Description | Data | Compliance | Description | Data |
|---|---|---|---|---|---|
| No B 1 Sign Lettering & Contrast? | | No | N/A | B 2 Sign Lettering & Contrast? | N/A |
| No B 1 Clear Floor Space Slope (%) | | 2.8 | N/A | B 2 Clear Floor Space Slope (%) | N/A |
| No B 1 Clear Floor Space XSlope (%) | | 7.5 | N/A | B 2 Clear Floor Space XSlope (%) | N/A |
| No B 1 DistanceTo XWalk (in) | | 72 | N/A | B 2 DistanceTo XWalk (in) | N/A |

Possible Solutions: Replace Signal Push Button With APS Button. Remove & Replace Sign.
