# Access Compliance Report Public Rights-of-Way (Pedestrian Signals)

Main Street: HEWES\_AVE Cross Street: 17TH\_ST Location: NE

ADA ID: SGRK211008122855 Signal Type: One Push Button-Non APS Overall Compliance: No Severity Scores: BTN 1: 35 BTN 2: N/A No BTN: N/A

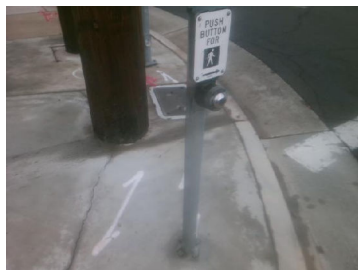
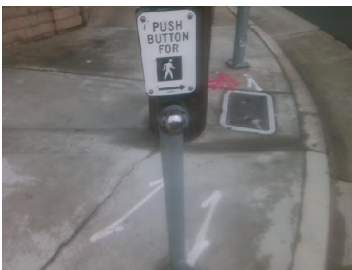
| No B 1 Pilot Light? | No | N/A B 2 Pilot Light? | N/A |

| Compliance | Description | Data | Compliance | Description | Data |
|---|---|---|---|---|---|
| No B 1 Clear Floor Space Slope (%) | 3.6 | N/A | B 2 Clear Floor Space Slope (%) | N/A | |
| No B 1 Clear Floor Space XSlope (%) | 8.4 | N/A | B 2 Clear Floor Space XSlope (%) | N/A | |

Possible Solutions: Replace Signal Push Button With APS Button. Remove and Replace Clear Space.
