# Access Compliance Report Public Rights-of-Way (Pedestrian Signals)

Main Street: 17TH\_ST Cross Street: HEWES\_AVE Location: SW

ADA ID: SGRK211008123215 Signal Type: One Push Button-Non APS Overall Compliance: No Severity Scores: BTN 1: 35 BTN 2: N/A No BTN: N/A

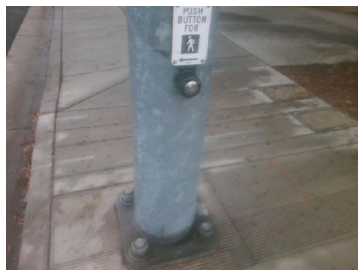
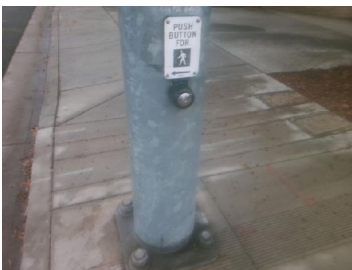
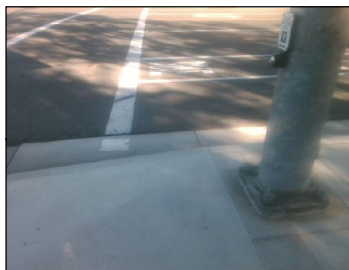
| No B 1 Pilot Light? | No | N/A B 2 Pilot Light? | N/A |

| Compliance | Description | Data | Compliance | Description | Data |
|---|---|---|---|---|---|
| No | B 1 Clear Floor Space Slope (%) | 3.4 | N/A | B 2 Clear Floor Space Slope (%) | N/A |
| No | B 1 Clear Floor Space XSlope (%) | 8.4 | N/A | B 2 Clear Floor Space XSlope (%) | N/A |

Possible Solutions: Replace Signal Push Button With APS Button. Remove and Replace Clear Space.

OC Std/PROW: R404.2, R404.3, MUTCD 4e.08
