# Access Compliance Report

## Public Rights-of-Way

### (Pedestrian Signals)

Main Street: **IRVINE\_AVE** Cross Street: **UNIVERSITY\_DR** Location: **NW**

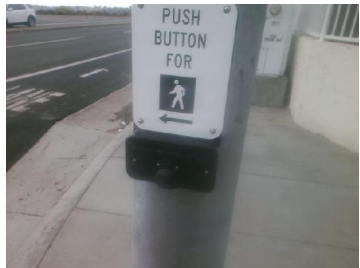
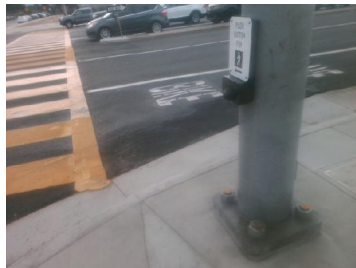
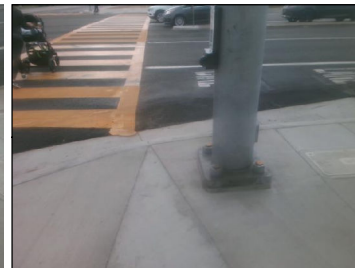
ADA ID: **SGRK211018112937** Signal Type: **One Push Button-Non APS** Overall Compliance: **No** Severity Scores: **BTN 1: 35** **BTN 2: N/A** **No BTN: N/A**

| Compliance | Description | Data | Compliance | Description | Data |
|---|---|---|---|---|---|
| <b>No</b> | B 1 Clear Floor Space Slope (%) | <b>2.5</b> | <b>N/A</b> | B 2 Clear Floor Space Slope (%) | <b>N/A</b> |

Possible Solutions: Replace Signal Push Button With APS Button. Remove and Replace Clear Space.
