# Access Compliance Report Public Rights-of-Way (Pedestrian Signals)

Main Street: UNIVERSITY\_DR Cross Street: IRVINE\_AVE Location: S

ADA ID: SGRK211018113508 Signal Type: One Push Button-Non APS Overall Compliance: No Severity Scores: BTN 1: 35 BTN 2: N/A No BTN: N/A

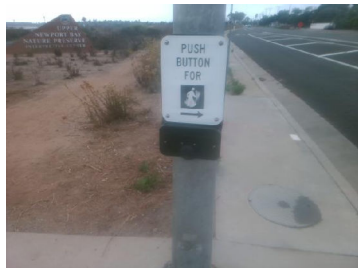
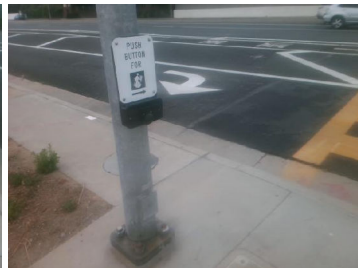
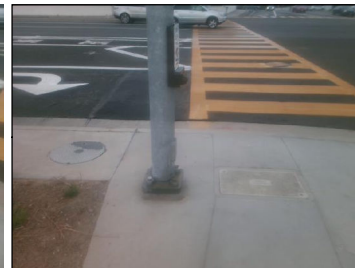
| No B 1 Pilot Light? | No | N/A B 2 Pilot Light? | N/A |

| Compliance | Description | Data | Compliance | Description | Data |
|---|---|---|---|---|---|
| No B 1 Clear Floor Space Slope (%) | 3.7 | N/A | B 2 Clear Floor Space Slope (%) | N/A | |

Possible Solutions: Replace Signal Push Button With APS Button. Remove and Replace Clear Space.

OC Std/PROW: R404.2, R404.3, MUTCD 4e.08
