# Access Compliance Report Public Rights-of-Way (Pedestrian Signals)

Main Street: **UNIVERSITY\_DR** Cross Street: **IRVINE\_AVE** Location: **S**

ADA ID: **SGRK211018113630** Signal Type: **One Push Button-Non APS** Overall Compliance: **No** Severity Scores: **BTN 1: 35** **BTN 2: N/A** **No BTN: N/A**

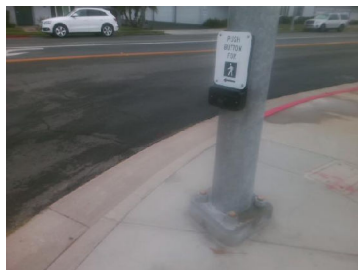
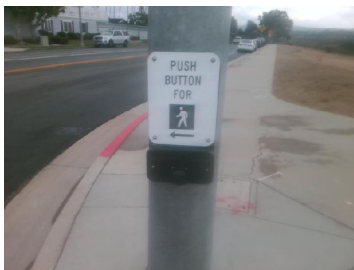
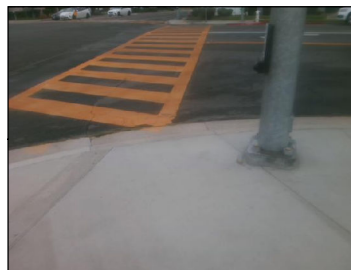
| <b>No</b> B 1 Pilot Light? | <b>No</b> | <b>N/A</b> B 2 Pilot Light? | <b>N/A</b> |

| Compliance | Description | Data | Compliance | Description | Data |
|---|---|---|---|---|---|
| <b>No</b> | B 1 Clear Floor Space Slope (%) | <b>2.2</b> | <b>N/A</b> | B 2 Clear Floor Space Slope (%) | <b>N/A</b> |

Possible Solutions: Replace Signal Push Button With APS Button. Remove and Replace Clear Space.

OC Std/PROW: **R404.2, R404.3, MUTCD 4e.08**
