# Access Compliance Report Public Rights-of-Way (Pedestrian Signals)

Main Street: **IRVINE\_AVE** Cross Street: **UNIVERSITY\_DR** Location: **E**

ADA ID: **SGRK211018114445** Signal Type: **One Push Button-Non APS** Overall Compliance: **No** Severity Scores: **BTN 1: 35** **BTN 2: N/A** **No BTN: N/A**

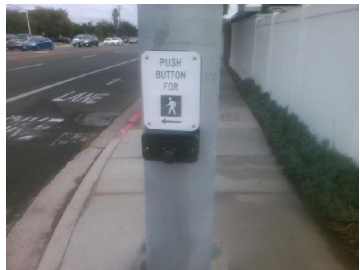
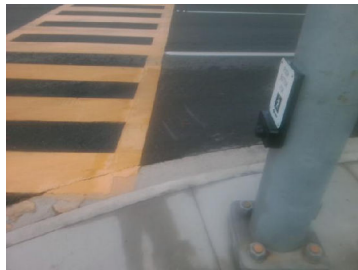
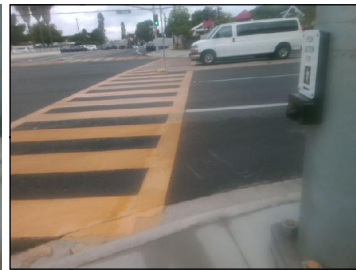
| <b>No</b> B 1 Pilot Light? | <b>No</b> | <b>N/A</b> B 2 Pilot Light? | <b>N/A</b> |

| Compliance | Description | Data | Compliance | Description | Data |
|---|---|---|---|---|---|
| <b>No</b> | B 1 Clear Floor Space Slope (%) | <b>2.7</b> | <b>N/A</b> | B 2 Clear Floor Space Slope (%) | <b>N/A</b> |

**Possible Solutions: Replace Signal Push Button With APS Button. Remove and Replace Clear Space.**

**OC Std/PROW: R404.2, R404.3, MUTCD 4e.08**
