# Access Compliance Report Public Rights-of-Way (Pedestrian Signals)

Main Street: **ANTONIO\_PKWY** Cross Street: **OAKTREE** Location: **SE**

ADA ID: **SGRK211019113033** Signal Type: **One Push Button-APS** Overall Compliance: **No** Severity Scores: **BTN 1: 25** **BTN 2: N/A** **No BTN: N/A**

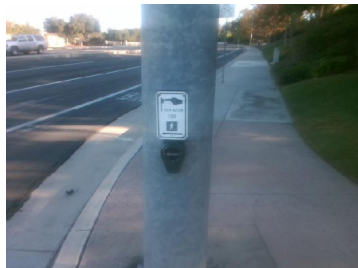
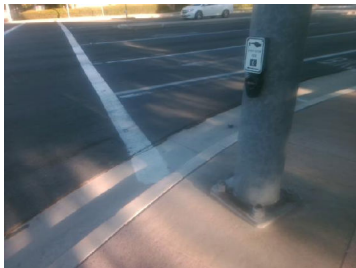
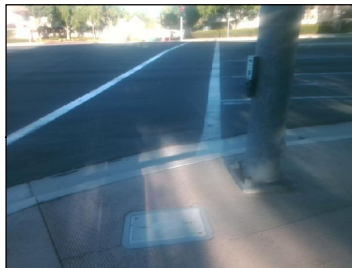
| Compliance | Description | Data | Compliance | Description | Data |
|---|---|---|---|---|---|
| <b>No</b> B 1 Clear Floor Space Slope (%) | | <b>4.8</b> | <b>N/A</b> | B 2 Clear Floor Space Slope (%) | <b>N/A</b> |

Possible Solutions: Remove and Replace Clear Space.

OC Std/PROW: **R404.2, R404.3**
