# Access Compliance Report Public Rights-of-Way (Pedestrian Signals)

Main Street: SWEETWATER Cross Street: ANTONIO\_PKWY Location: S

ADA ID: SGRK211019115413 Signal Type: One Push Button-APS Overall Compliance: No Severity Scores: BTN 1: 25 BTN 2: N/A No BTN: N/A

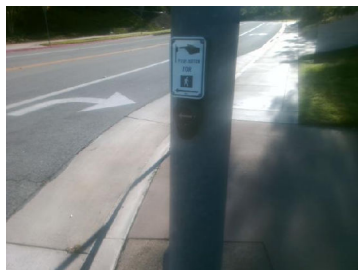
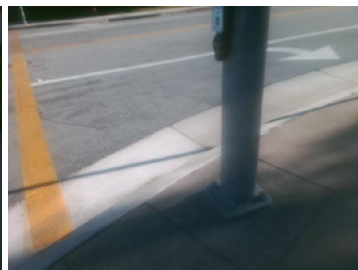
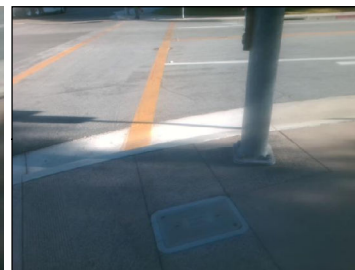
| Compliance | Description | Data | Compliance | Description | Data |
|---|---|---|---|---|---|
| No B 1 Clear Floor Space Slope (%) | 2.1 | N/A | B 2 Clear Floor Space Slope (%) | N/A | |
| No B 1 Clear Floor Space XSlope (%) | 7.1 | N/A | B 2 Clear Floor Space XSlope (%) | N/A | |

Possible Solutions: Remove and Replace Clear Space.

OC Std/PROW: R404.2, R404.3
