# Access Compliance Report Public Rights-of-Way (Pedestrian Signals)

Main Street: **ANTONIO\_PKWY** Cross Street: **SWEETWATER** Location: **E**

ADA ID: **SGRK211019115753** Signal Type: **One Push Button-APS** Overall Compliance: **No** Severity Scores: **BTN 1: 25** **BTN 2: N/A** **No BTN: N/A**

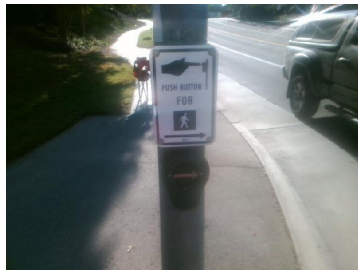
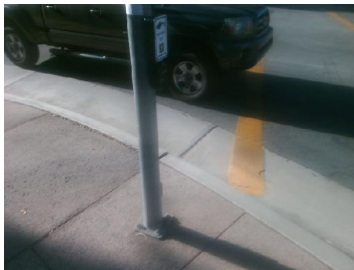
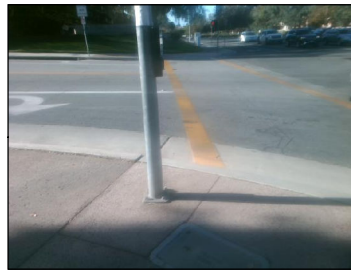
| Compliance | Description | Data | Compliance | Description | Data |
|---|---|---|---|---|---|
| <b>No</b> | B 1 Clear Floor Space Slope (%) | <b>2.6</b> | <b>N/A</b> | B 2 Clear Floor Space Slope (%) | <b>N/A</b> |

Possible Solutions: Remove and Replace Clear Space.

OC Std/PROW: **R404.2, R404.3**
