# Access Compliance Report Public Rights-of-Way (Pedestrian Signals)

Main Street: **ANTONIO\_PKWY** Cross Street: **SWEETWATER** Location: **E**

ADA ID: **SGRK211019120018** Signal Type: **One Push Button-APS** Overall Compliance: **No** Severity Scores: **BTN 1: 25** **BTN 2: N/A** **No BTN: N/A**

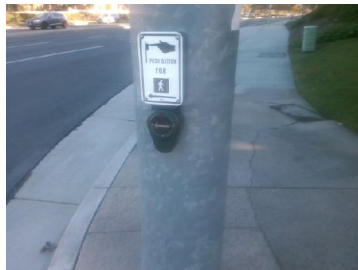
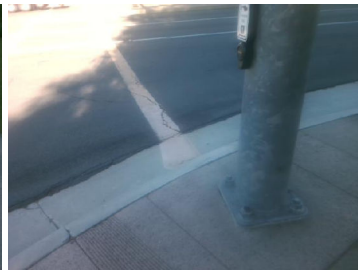
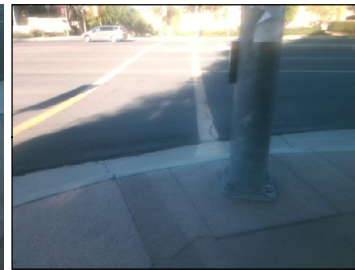
| Compliance | Description | Data | Compliance | Description | Data |
|---|---|---|---|---|---|
| <b>No</b> | B 1 Clear Floor Space Slope (%) | <b>2.8</b> | <b>N/A</b> | B 2 Clear Floor Space Slope (%) | <b>N/A</b> |

Possible Solutions: Remove and Replace Clear Space.

OC Std/PROW: **R404.2, R404.3**

Total Cost: \$ **378**
