# Access Compliance Report Public Rights-of-Way (Pedestrian Signals)

Main Street: GRASSY\_KNOLL\_LN Cross Street: MEANDERING\_TRAIL Location: NW

ADA ID: SGRK211019131924 Signal Type: One Push Button-Non APS Overall Compliance: No Severity Scores: BTN 1: 25 BTN 2: N/A No BTN: N/A

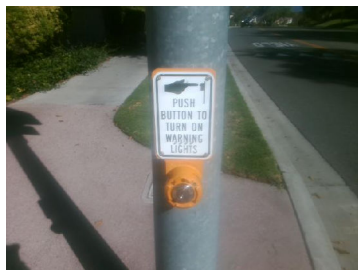
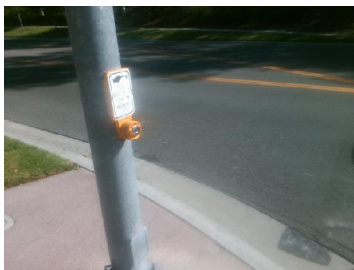
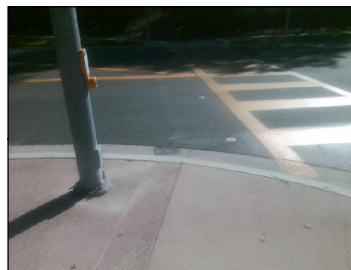
| Compliance | Description | Data | Compliance | Description | Data |
|---|---|---|---|---|---|
| No | B 1 Clear Floor Space XSlope (%) | 3.6 | N/A | B 2 Clear Floor Space XSlope (%) | N/A |
| No | B 1 DistanceTo XWalk (in) | 93 | N/A | B 2 DistanceTo XWalk (in) | N/A |

Possible Solutions: Replace Signal Push Button With APS Button. Remove & Relocate Sign.

OC Std/PROW: MUTCD 4e.08, R404.2

Total Cost: \$ 650
