# Access Compliance Report Public Rights-of-Way (Pedestrian Signals)

Main Street: **ANTONIO\_PKWY** Cross Street: **BENJAMIN\_DR** Location: **SW**

ADA ID: **SGRK211020125816** Signal Type: **One Push Button-Non APS** Overall Compliance: **No** Severity Scores: **BTN 1: 35** **BTN 2: N/A** **No BTN: N/A**

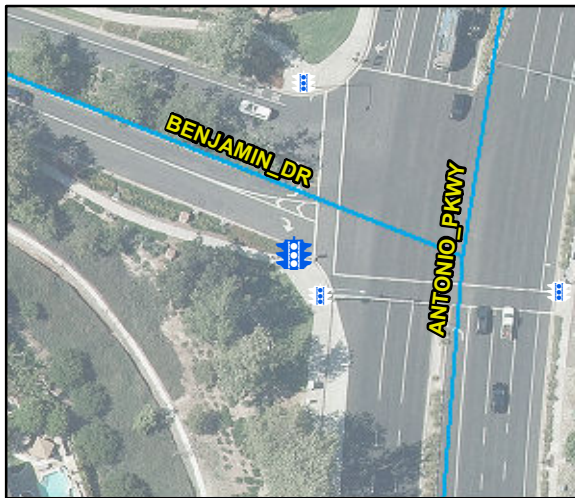
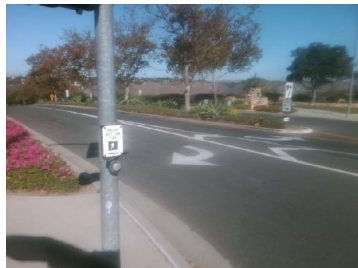
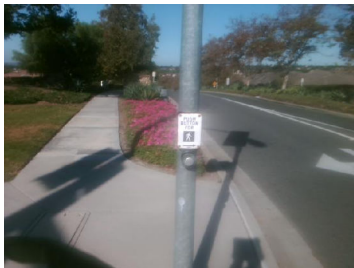
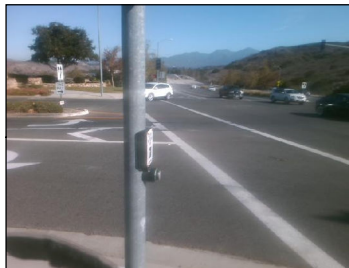
| Compliance | Description | Data | Compliance | Description | Data |
|---|---|---|---|---|---|
| <b>No</b> B 1 Clear Floor Space Slope (%) | | <b>4.7</b> | <b>N/A</b> | B 2 Clear Floor Space Slope (%) | <b>N/A</b> |
| <b>No</b> B 1 Clear Floor Space XSlope (%) | | <b>2.5</b> | <b>N/A</b> | B 2 Clear Floor Space XSlope (%) | <b>N/A</b> |

Possible Solutions: Replace Signal Push Button With APS Button. Remove and Replace Clear Space.

OC Std/PROW: **R404.2, R404.3, MUTCD 4e.08**
