# Access Compliance Report Public Rights-of-Way (Pedestrian Signals)

Main Street: **ANTONIO\_PKWY** Cross Street: **BENJAMIN\_DR** Location: **SW**

ADA ID: **SGRK211020131147** Signal Type: **One Push Button-Non APS** Overall Compliance: **No** Severity Scores: **BTN 1: 35** **BTN 2: N/A** **No BTN: N/A**

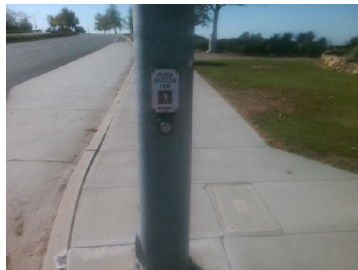
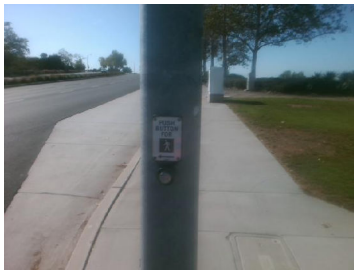
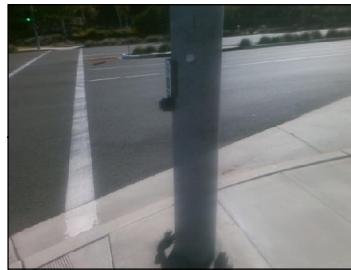
| Compliance | Description | Data | Compliance | Description | Data |
|---|---|---|---|---|---|
| <b>No</b> B 1 Clear Floor Space XSlope (%) | | <b>4.2</b> | <b>N/A</b> | B 2 Clear Floor Space XSlope (%) | <b>N/A</b> |

Possible Solutions: Replace Signal Push Button With APS Button. Remove and Replace Clear Space.

OC Std/PROW: **R404.2, MUTCD 4e.08**
