# Access Compliance Report Public Rights-of-Way (Pedestrian Signals)

Main Street: CROWN\_VALLEY\_PKWY Cross Street: ANTONIO\_PKWY Location: N

ADA ID: SGRK211022134033 Signal Type: One Push Button-Non APS Overall Compliance: No Severity Scores: BTN 1: 35 BTN 2: N/A No BTN: N/A

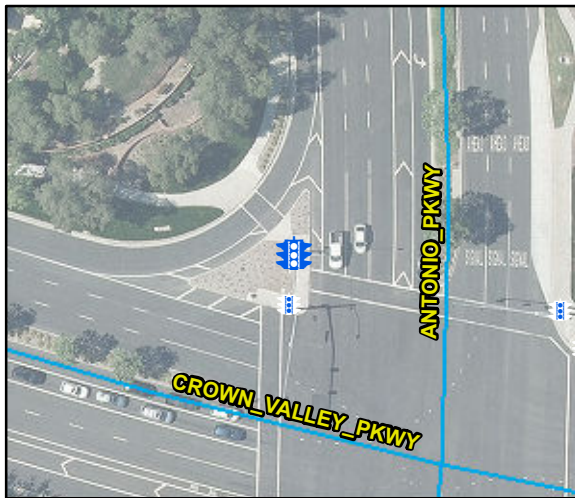
| Compliance | Description | Data | Compliance | Description | Data |
|---|---|---|---|---|---|
| No | B 1 Clear Floor Space XSlope (%) | 2.5 | N/A | B 2 Clear Floor Space XSlope (%) | N/A |
| No | B 1 DistanceTo XWalk (in) | 86 | N/A | B 2 DistanceTo XWalk (in) | N/A |

Possible Solutions: Replace Signal Push Button With APS Button. Remove & Relocate Sign.

OC Std/PROW: MUTCD 4e.08, R404.2

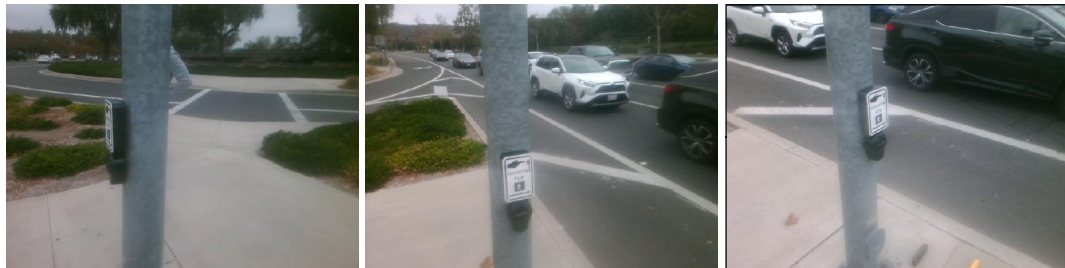
| No | B 1 Pilot Light? | No | N/A | B 2 Pilot Light? | N/A |

Total Cost: \$ 650
