# Access Compliance Report Public Rights-of-Way (Pedestrian Signals)

Main Street: CROWN\_VALLEY\_PKWY Cross Street: ANTONIO\_PKWY Location: SW

ADA ID: SGRK211022135823 Signal Type: One Push Button-Non APS Overall Compliance: No Severity Scores: BTN 1: 35 BTN 2: N/A No BTN: N/A

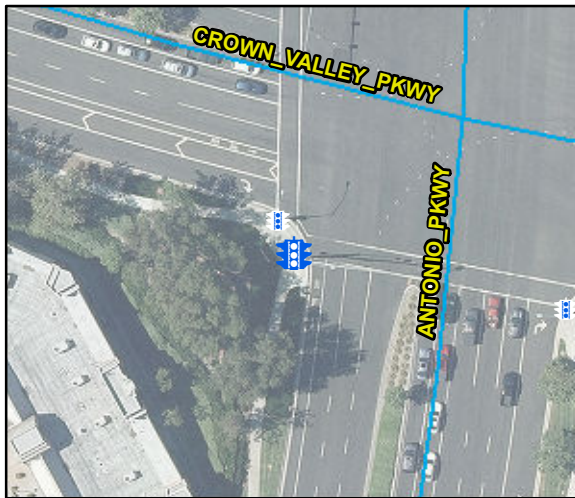
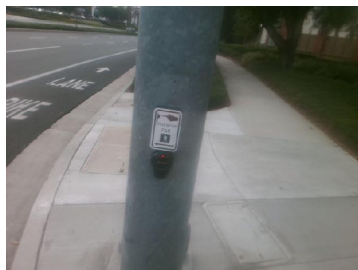
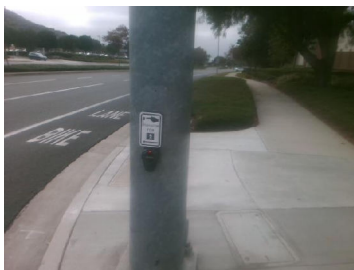
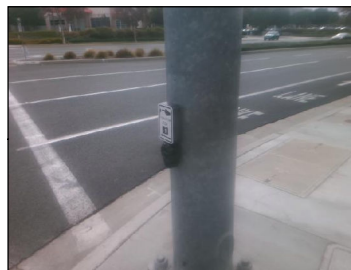
Surveyor Notes: Clear Space in Ramp

| Compliance | Description | Data | Compliance | Description | Data |
|---|---|---|---|---|---|
| No B 1 Clear Floor Space XSlope (%) | | 4.9 | N/A | B 2 Clear Floor Space XSlope (%) | N/A |

Possible Solutions: Replace Signal Push Button With APS Button. Remove and Replace Clear Space.
