# Access Compliance Report Public Rights-of-Way (Pedestrian Signals)

Main Street: CROWN\_VALLEY\_PKWY Cross Street: ANTONIO\_PKWY Location: S

ADA ID: SGRK211022140447 Signal Type: One Push Button-Non APS Overall Compliance: No Severity Scores: BTN 1: 35 BTN 2: N/A No BTN: N/A

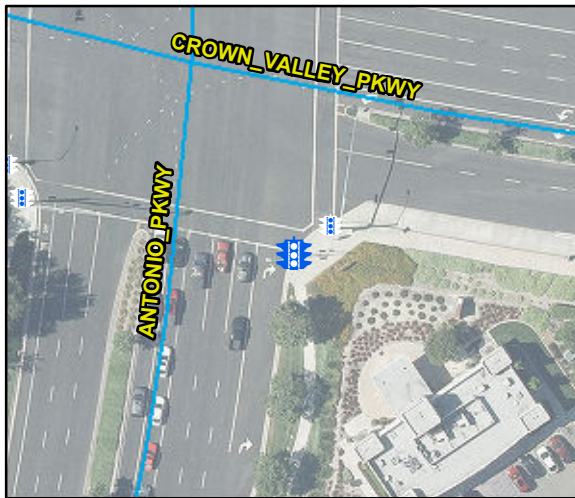
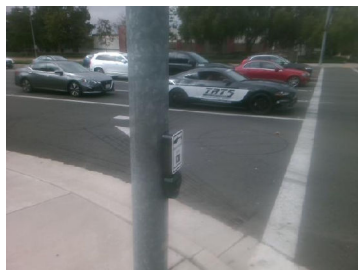
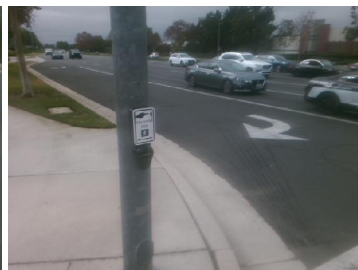
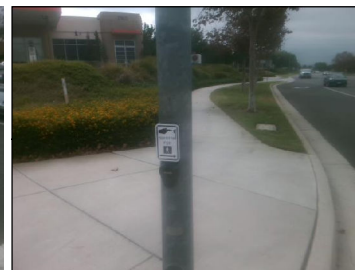
| No B 1 Pilot Light? | No | N/A B 2 Pilot Light? | N/A |

| Compliance | Description | Data | Compliance | Description | Data |
|---|---|---|---|---|---|
| No B 1 Clear Floor Space Slope (%) | 4.1 | N/A | B 2 Clear Floor Space Slope (%) | N/A | |

Possible Solutions: Replace Signal Push Button With APS Button. Remove and Replace Clear Space.

OC Std/PROW: R404.2, R404.3, MUTCD 4e.08
