# Access Compliance Report Public Rights-of-Way (Pedestrian Signals)

Main Street: CROWN\_VALLEY\_PKWY Cross Street: ANTONIO\_PKWY Location: S

ADA ID: SGRK211022140726 Signal Type: One Push Button-Non APS Overall Compliance: No Severity Scores: BTN 1: 35 BTN 2: N/A No BTN: N/A

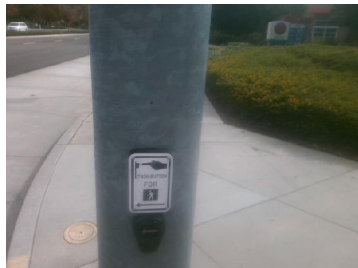
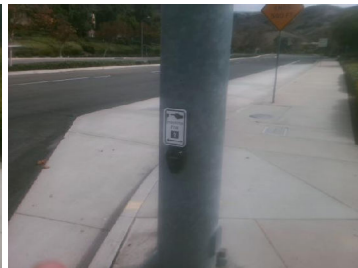
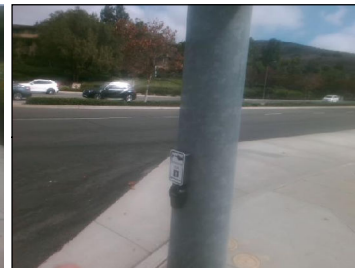
| No B 1 Pilot Light? | No | N/A B 2 Pilot Light? | N/A |

| Compliance | Description | Data | Compliance | Description | Data |
|---|---|---|---|---|---|
| No B 1 Clear Floor Space XSlope (%) | | 4.1 | N/A | B 2 Clear Floor Space XSlope (%) | N/A |

Possible Solutions: Replace Signal Push Button With APS Button. Remove and Replace Clear Space.
