# Access Compliance Report Public Rights-of-Way (Pedestrian Signals)

Main Street: **ANTONIO\_PKWY** Cross Street: **CROWN\_VALLEY\_PKWY** Location: **E**

ADA ID: **SGRK211022141311** Signal Type: **One Push Button-Non APS** Overall Compliance: **No** Severity Scores: **BTN 1: 35** **BTN 2: N/A** **No BTN: N/A**

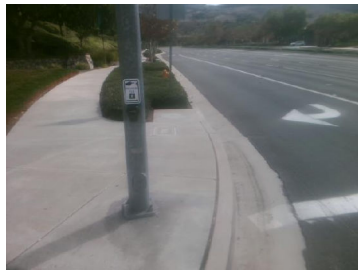
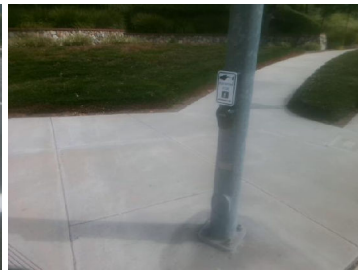
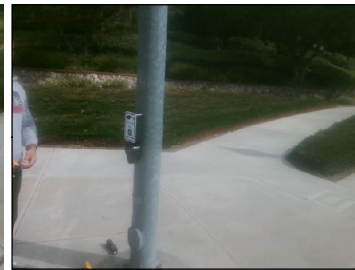
| Compliance | Description | Data | Compliance | Description | Data |
|---|---|---|---|---|---|
| <b>No</b> | B 1 Clear Floor Space XSlope (%) | <b>8.8</b> | <b>N/A</b> | B 2 Clear Floor Space XSlope (%) | <b>N/A</b> |

**Possible Solutions: Replace Signal Push Button With APS Button. Remove and Replace Clear Space.**

**OC Std/PROW: R404.2, MUTCD 4e.08**
