# Access Compliance Report Public Rights-of-Way (Pedestrian Signals)

Main Street: ANTONIO\_PKWY Cross Street: CROWN\_VALLEY\_PKWY Location: E

ADA ID: SGRK211022141514 Signal Type: One Push Button-Non APS Overall Compliance: No Severity Scores: BTN 1: 35 BTN 2: N/A No BTN: N/A

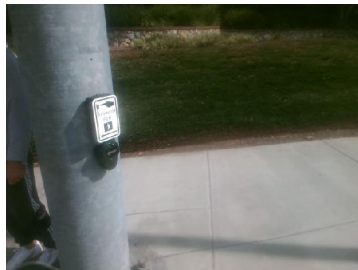
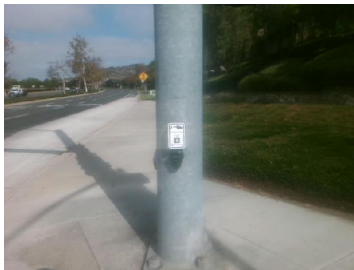
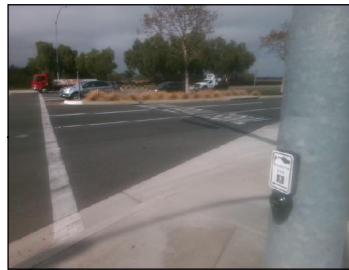
| Compliance | Description | Data | Compliance | Description | Data |
|---|---|---|---|---|---|
| No B 1 Clear Floor Space XSlope (%) | 2.3 | N/A | B 2 Clear Floor Space XSlope (%) | N/A | |
| No B 1 DistanceTo Curb (in) | 80 | N/A | B 2 DistanceTo Curb (in) | N/A | |

Possible Solutions: Replace Signal Push Button With APS Button. Remove & Relocate Sign.

OC Std/PROW: MUTCD 4e.08, R404.2

Total Cost: \$ 650
