# Access Compliance Report Public Rights-of-Way (Pedestrian Signals)

Main Street: **O\_NEILL\_DR** Cross Street: **CROWN\_VALLEY\_PKWY** Location: **SW**

ADA ID: **SGRK211025140418** Signal Type: **One Push Button-Non APS** Overall Compliance: **No** Severity Scores: **BTN 1: 10** **BTN 2: N/A** **No BTN: N/A**

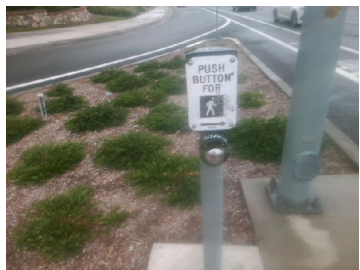
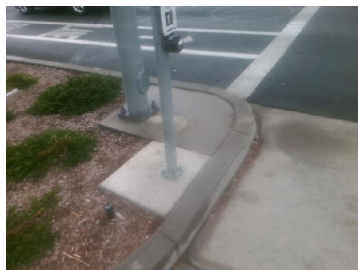
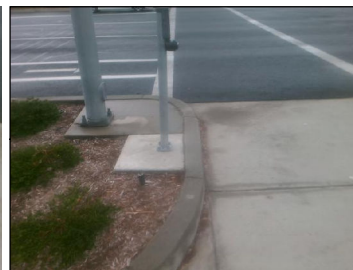
| <b>No</b> B 1 Pilot Light? | <b>No</b> | <b>N/A</b> B 2 Pilot Light? | <b>N/A</b> |

Possible Solutions: Replace Signal Push Button With APS Button.
