# Access Compliance Report Public Rights-of-Way (Pedestrian Signals)

Main Street: CROWN\_VALLEY\_PKWY Cross Street: CROWN\_VALLEY\_PKWY Location: NW

ADA ID: SGRK211026120429 Signal Type: One Push Button-Non APS Overall Compliance: No Severity Scores: BTN 1: 35 BTN 2: N/A No BTN: N/A

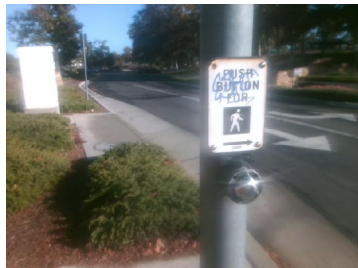
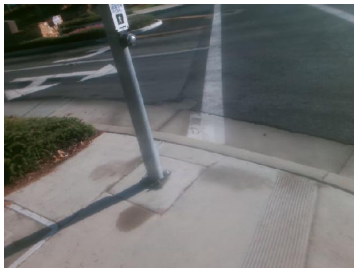
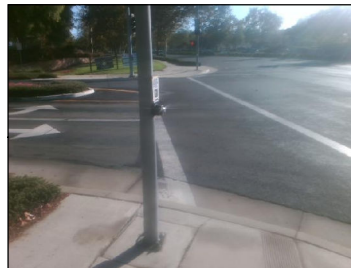
| Compliance | Description | Data | Compliance | Description | Data |
|---|---|---|---|---|---|
| No | B 1 Clear Floor Space XSlope (%) | 3.7 | N/A | B 2 Clear Floor Space XSlope (%) | N/A |

Possible Solutions: Replace Signal Push Button With APS Button. Remove and Replace Clear Space.
