# Access Compliance Report Public Rights-of-Way (Pedestrian Signals)

Main Street: O NEILL\_DR Cross Street: O NEILL\_DR Location: NE

ADA ID: SGRK211026131650 Signal Type: One Push Button-Non APS Overall Compliance: No Severity Scores: BTN 1: 35 BTN 2: N/A No BTN: N/A

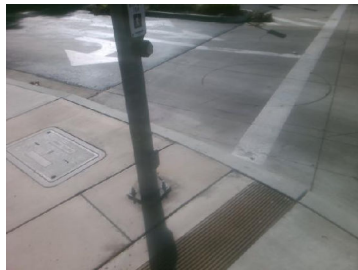
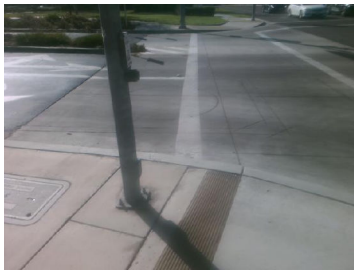
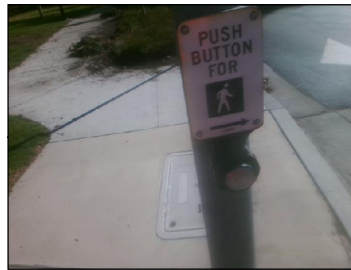
| Compliance | Description | Data | Compliance | Description | Data |
|---|---|---|---|---|---|
| No | B 1 Clear Floor Space XSlope (%) | 2.7 | N/A | B 2 Clear Floor Space XSlope (%) | N/A |

| No | B 1 Pilot Light? | No | N/A | B 2 Pilot Light? | N/A |

Possible Solutions: Replace Signal Push Button With APS Button. Remove and Replace Clear Space.

OC Std/PROW: R404.2, MUTCD 4e.08

Total Cost: \$ 1278
