# Access Compliance Report Public Rights-of-Way (Pedestrian Signals)

Main Street: O\_NEILL\_DR Cross Street: O\_NEILL\_DR Location: SE

ADA ID: SGRK211026132118 Signal Type: One Push Button-Non APS Overall Compliance: No Severity Scores: BTN 1: 10 BTN 2: N/A No BTN: N/A

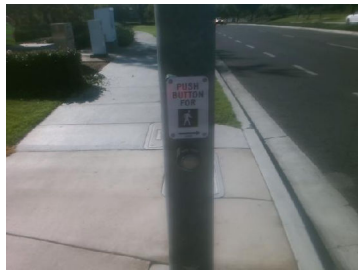
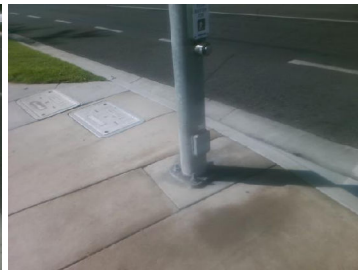
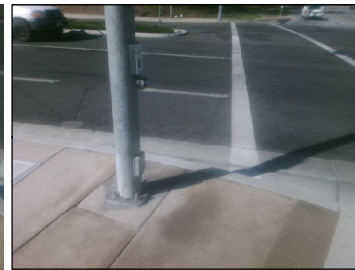
| No B 1 Pilot Light? | No | N/A B 2 Pilot Light? | N/A |

Possible Solutions: Replace Signal Push Button With APS Button.
