# Access Compliance Report Public Rights-of-Way (Pedestrian Signals)

Main Street: **ANTONIO\_PKWY** Cross Street: **SWEETWATER** Location: **N**

ADA ID: **SGRK211028172201** Signal Type: **One Push Button-APS** Overall Compliance: **No** Severity Scores: **BTN 1: 25** **BTN 2: N/A** **No BTN: N/A**

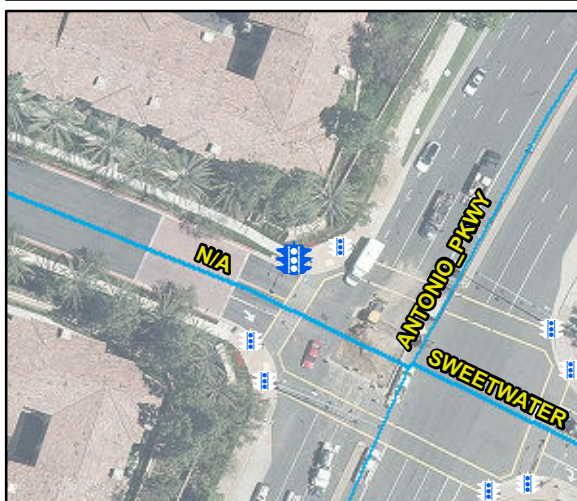
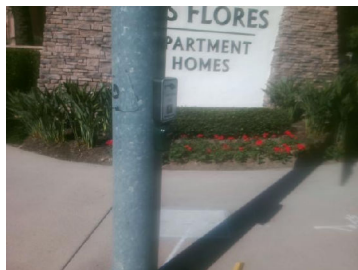
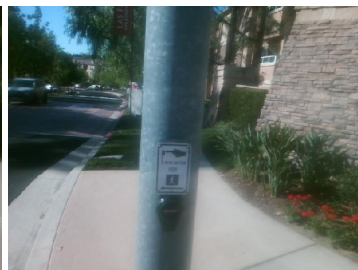
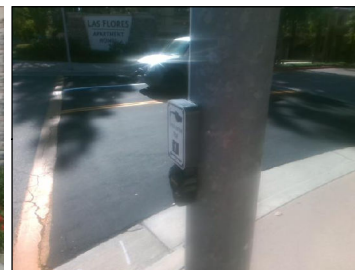
| Compliance | Description | Data | Compliance | Description | Data |
|---|---|---|---|---|---|
| <b>No</b> | B 1 Clear Floor Space Slope (%) | <b>2.2</b> | <b>N/A</b> | B 2 Clear Floor Space Slope (%) | <b>N/A</b> |

Possible Solutions: Remove and Replace Clear Space.

OC Std/PROW: **R404.2, R404.3**

Total Cost: \$ **378**
