# Access Compliance Report Public Rights-of-Way (Pedestrian Signals)

Main Street: WINDMILL\_AVE Cross Street: ANTONIO\_PKWY Location: N

ADA ID: SGRK211029135542 Signal Type: Two Push Buttons-APS Overall Compliance: No Severity Scores: BTN 1: 25 BTN 2: 25 No BTN: N/A

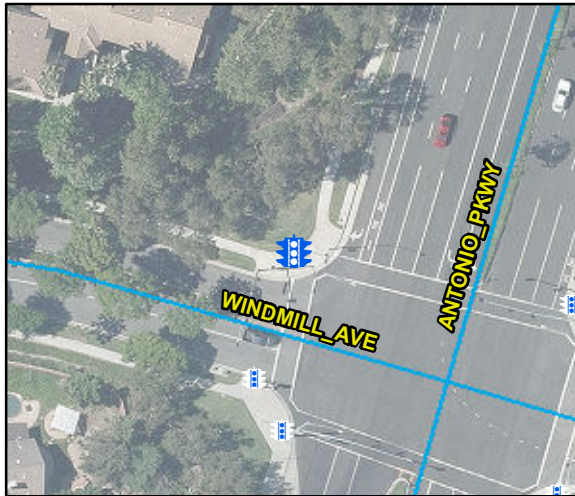
OC Std/PROW: MUTCD 4e.08, R404.2

Possible Solutions: Replace Signal Push Button With APS Button. Remove & Relocate Sign. Remove and Replace Clear Space.

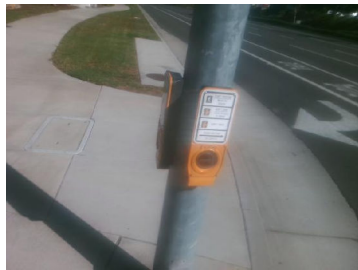
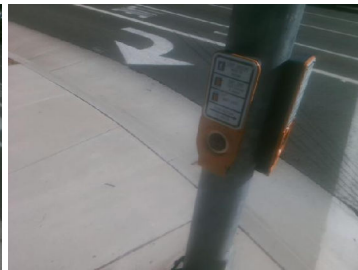
| Compliance | Description | Data | Compliance | Description | Data |
|---|---|---|---|---|---|
| No | B 1 Clear Floor Space XSlope (%) | 8.8 | No | B 2 Clear Floor Space XSlope (%) | 5.6 |
| No | B 1 DistanceTo Curb (in) | 15 | Yes | B 2 DistanceTo Curb (in) | 25 |
