# Access Compliance Report Public Rights-of-Way (Pedestrian Signals)

Main Street: **ANTONIO\_PKWY** Cross Street: **WINDMILL\_AVE** Location: **E**

ADA ID: **SGRK211029141848** Signal Type: **One Push Button-APS** Overall Compliance: **No** Severity Scores: **BTN 1: 25** **BTN 2: N/A** **No BTN: N/A**

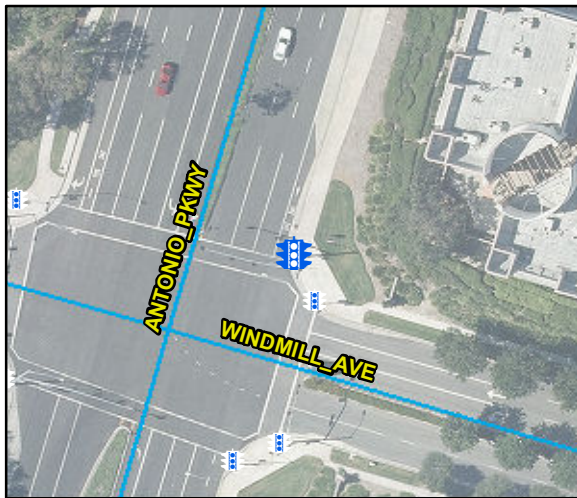
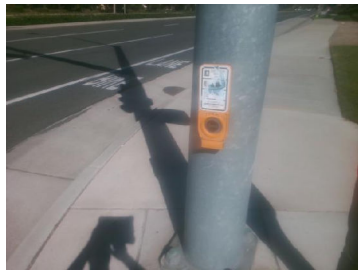
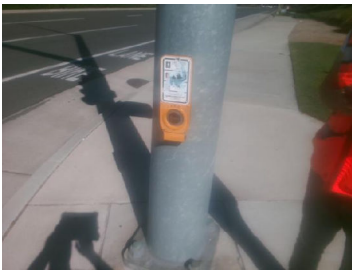
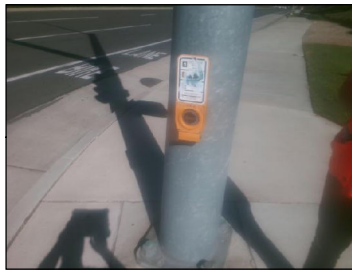
| Compliance | Description | Data | Compliance | Description | Data |
|---|---|---|---|---|---|
| No B 1 Clear Floor Space XSlope (%) | | 3.6 | N/A | B 2 Clear Floor Space XSlope (%) | N/A |

Possible Solutions: Remove and Replace Clear Space.

OC Std/PROW: **R404.2**
