# Access Compliance Report Public Rights-of-Way (Pedestrian Signals)

Main Street: **ANTONIO\_PKWY** Cross Street: **TERRACE\_RD** Location: **NE**

ADA ID: **SGRK211115163451** Signal Type: **One Push Button-Non APS** Overall Compliance: **No** Severity Scores: **BTN 1: 35** **BTN 2: N/A** **No BTN: N/A**

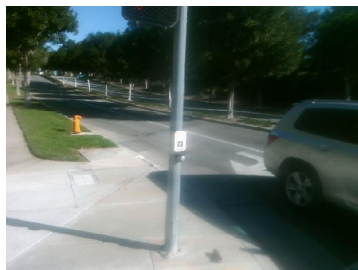
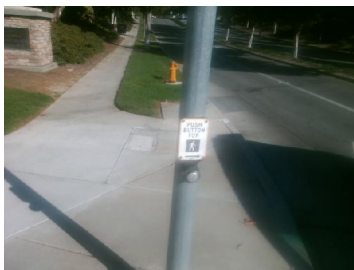
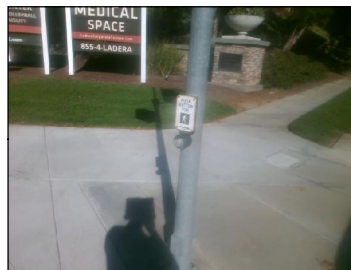
| <b>No</b> B 1 Pilot Light? | <b>No</b> | <b>N/A</b> B 2 Pilot Light? | <b>N/A</b> |

| Compliance | Description | Data | Compliance | Description | Data |
|---|---|---|---|---|---|
| <b>No</b> B 1 Clear Floor Space Slope (%) | | <b>3.1</b> | <b>N/A</b> | B 2 Clear Floor Space Slope (%) | <b>N/A</b> |

**Possible Solutions: Replace Signal Push Button With APS Button. Remove and Replace Clear Space.**

**OC Std/PROW: R404.2, R404.3, MUTCD 4e.08**
