# Access Compliance Report Public Rights-of-Way (Pedestrian Signals)

Main Street: **SENDERO\_WAY** Cross Street: **ANTONIO\_PKWY** Location: **NW**

ADA ID: **SGRK211116133710** Signal Type: **One Push Button-Non APS** Overall Compliance: **No** Severity Scores: **BTN 1: 35** **BTN 2: N/A** **No BTN: N/A**

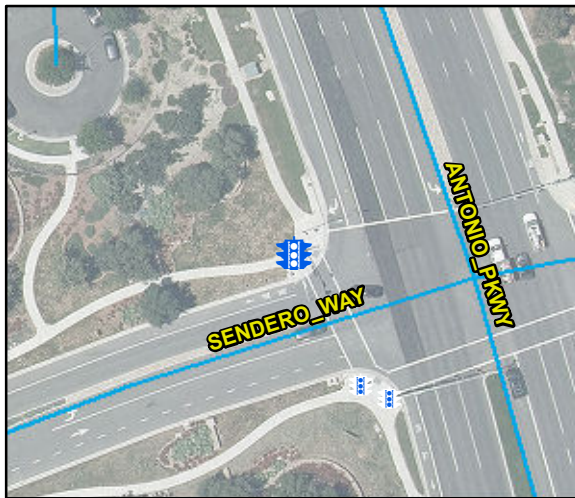
| Compliance | Description | Data | Compliance | Description | Data |
|---|---|---|---|---|---|
| <b>No</b> | B 1 Clear Floor Space Slope (%) | <b>10.5</b> | <b>N/A</b> | B 2 Clear Floor Space Slope (%) | <b>N/A</b> |
| <b>No</b> | B 1 Clear Floor Space XSlope (%) | <b>15</b> | <b>N/A</b> | B 2 Clear Floor Space XSlope (%) | <b>N/A</b> |
| <b>No</b> | B 1 DistanceTo Curb (in) | <b>128</b> | <b>N/A</b> | B 2 DistanceTo Curb (in) | <b>N/A</b> |

Possible Solutions: Replace Signal Push Button With APS Button. Remove & Relocate Sign.

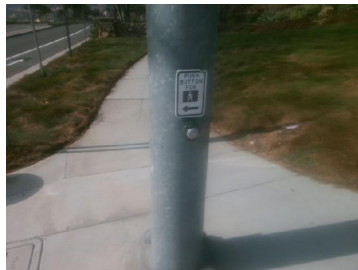
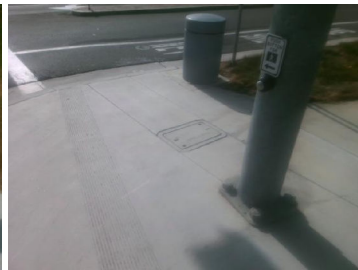
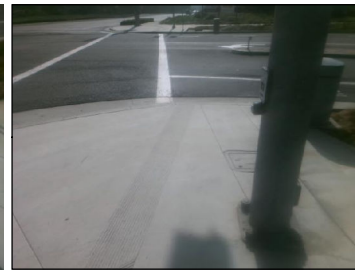
| <b>No</b> | B 1 Pilot Light? | <b>No</b> | <b>N/A</b> | B 2 Pilot Light? | <b>N/A</b> |
