# Access Compliance Report Public Rights-of-Way (Pedestrian Signals)

Main Street: **ANTONIO\_PKWY** Cross Street: **ANTONIO\_PKWY** Location: **S**

ADA ID: **SGRK211118114230** Signal Type: **One Push Button-Non APS** Overall Compliance: **No** Severity Scores: **BTN 1: 35** **BTN 2: N/A** **No BTN: N/A**

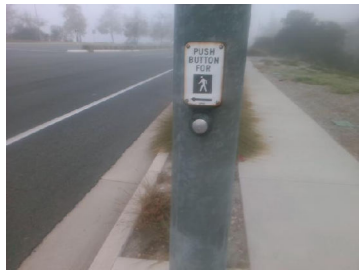
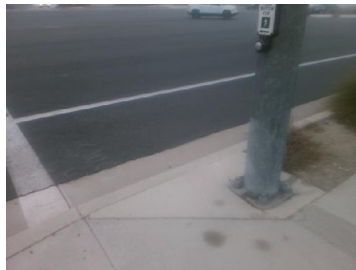
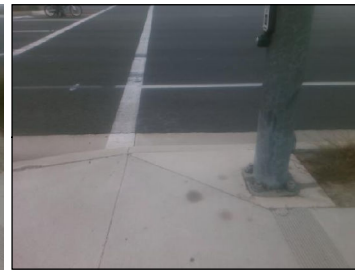
| <b>No</b> B 1 Pilot Light? | <b>No</b> | <b>N/A</b> B 2 Pilot Light? | <b>N/A</b> |

| Compliance | Description | Data | Compliance | Description | Data |
|---|---|---|---|---|---|
| <b>No</b> | B 1 Clear Floor Space XSlope (%) | <b>3.6</b> | <b>N/A</b> | B 2 Clear Floor Space XSlope (%) | <b>N/A</b> |

**Possible Solutions: Replace Signal Push Button With APS Button. Remove and Replace Clear Space.**
