# Access Compliance Report Public Rights-of-Way (Pedestrian Signals)

Main Street: REATA\_RD Cross Street: ORTEGA\_HWY Location: NE

ADA ID: SGRK211118131005 Signal Type: One Push Button-Non APS Overall Compliance: No Severity Scores: BTN 1: 35 BTN 2: N/A No BTN: N/A

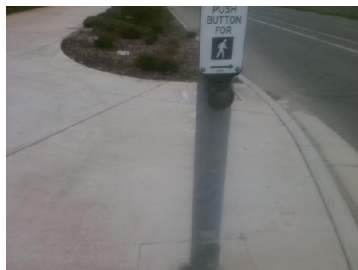
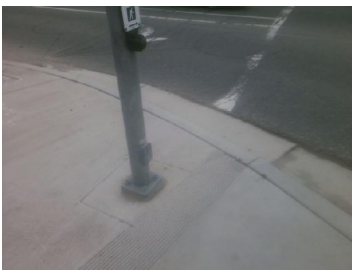
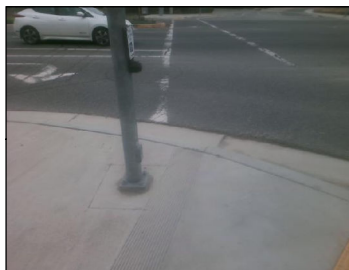
| Compliance | Description | Data | Compliance | Description | Data |
|---|---|---|---|---|---|
| No B 1 Clear Floor Space Slope (%) | | 4.3 | N/A | B 2 Clear Floor Space Slope (%) | N/A |

Possible Solutions: Replace Signal Push Button With APS Button. Remove and Replace Clear Space.
