# Access Compliance Report Public Rights-of-Way (Pedestrian Signals)

Main Street: ORTEGA\_HWY Cross Street: REATA\_RD Location: NW

ADA ID: SGRK211118140824 Signal Type: One Push Button-Non APS Overall Compliance: No Severity Scores: BTN 1: 60 BTN 2: N/A No BTN: N/A

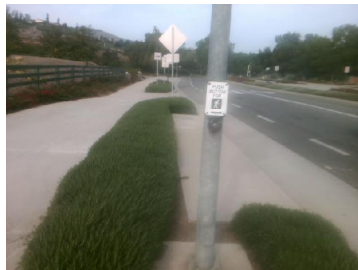
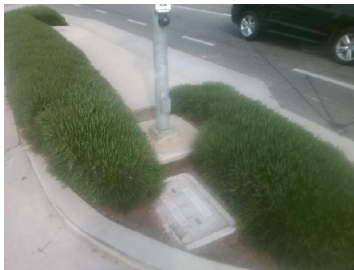
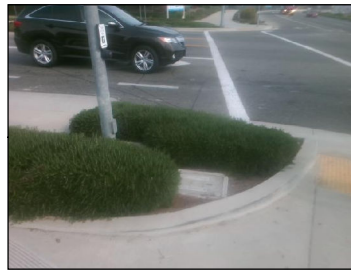
Surveyor Notes: Clear Space on Ramp

| No B 1 Pilot Light? | No | N/A B 2 Pilot Light? | N/A |

| Compliance | Description | Data | Compliance | Description | Data |
|---|---|---|---|---|---|
| No B 1 Clear Floor Space? | | Yes | N/A | B 2 Clear Floor Space? | N/A |
| No B 1 Clear Floor Space Slope (%) | | 6.9 | N/A | B 2 Clear Floor Space Slope (%) | N/A |
| No B 1 Clear Floor Space XSlope (%) | | 5.6 | N/A | B 2 Clear Floor Space XSlope (%) | N/A |

Possible Solutions: Replace Signal Push Button With APS Button. Provide PAR As Indicated. Remove and Replace Clear Space.
