# Access Compliance Report Public Rights-of-Way (Pedestrian Signals)

Main Street: ORTEGA\_HWY Cross Street: ORTEGA\_HWY Location: SW

ADA ID: SGRK211118141451 Signal Type: One Push Button-Non APS Overall Compliance: No Severity Scores: BTN 1: 35 BTN 2: N/A No BTN: N/A

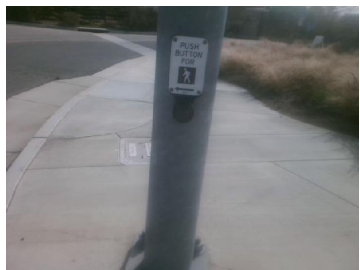
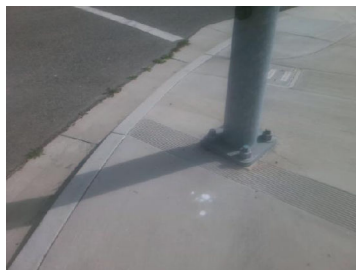
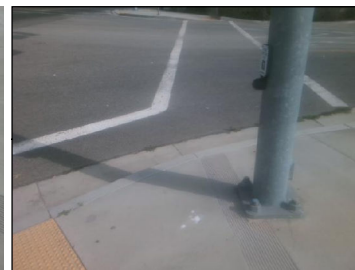
| Compliance | Description | Data | Compliance | Description | Data |
|---|---|---|---|---|---|
| No B 1 Clear Floor Space XSlope (%) | 2.3 | N/A | B 2 Clear Floor Space XSlope (%) | N/A | |

Possible Solutions: Replace Signal Push Button With APS Button. Remove and Replace Clear Space.
