# Access Compliance Report Public Rights-of-Way (Pedestrian Signals)

Main Street: **ANTONIO\_PKWY** Cross Street: **COW\_CAMP\_RD** Location: **E**

ADA ID: **SGRK211123131053** Signal Type: **One Push Button-Non APS** Overall Compliance: **No** Severity Scores: **BTN 1: 35** **BTN 2: N/A** **No BTN: N/A**

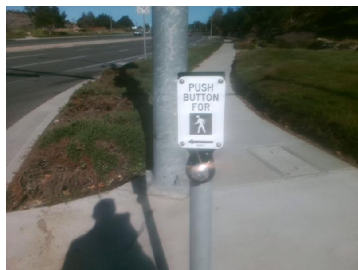
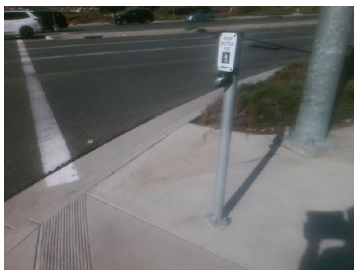
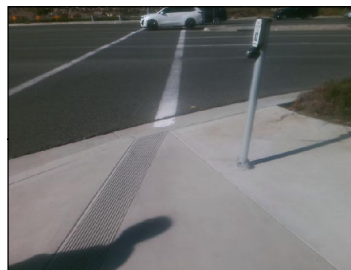
| <b>No</b> B 1 Pilot Light? | <b>No</b> | <b>N/A</b> B 2 Pilot Light? | <b>N/A</b> |

| Compliance | Description | Data | Compliance | Description | Data |
|---|---|---|---|---|---|
| <b>No</b> | B 1 Clear Floor Space XSlope (%) | <b>6.6</b> | <b>N/A</b> | B 2 Clear Floor Space XSlope (%) | <b>N/A</b> |

Possible Solutions: Replace Signal Push Button With APS Button. Remove and Replace Clear Space.
