# Access Compliance Report Public Rights-of-Way (Pedestrian Signals)

Main Street: COW\_CAMP\_RD Cross Street: CHIQUITA\_CANYON\_DR Location: NW

ADA ID: SGRK211124122002 Signal Type: One Push Button-Non APS Overall Compliance: No Severity Scores: BTN 1: 25 BTN 2: N/A No BTN: N/A

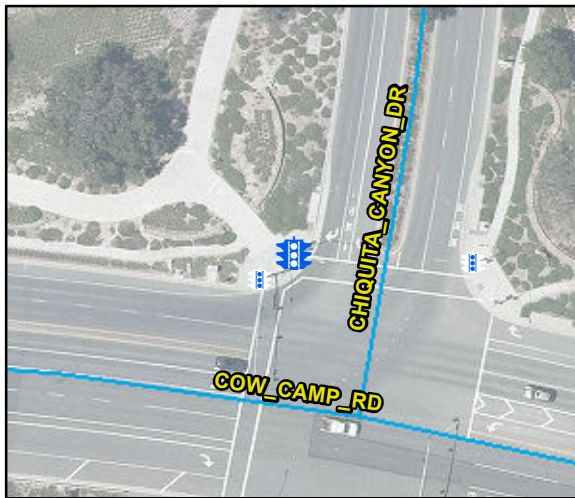
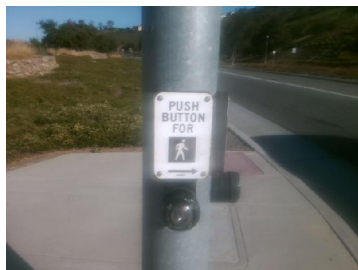
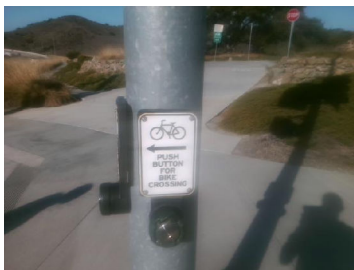
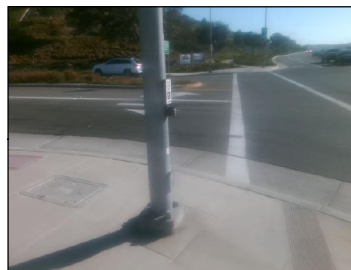
Surveyor Notes: Button 2 for Bike Lane

OC Std/PROW: R404.2, R404.3

| Compliance | Description | Data | Compliance | Description | Data |
|---|---|---|---|---|---|
| No | B 1 Clear Floor Space Slope (%) | 4 | N/A | B 2 Clear Floor Space Slope (%) | 6 |
| No | B 1 Clear Floor Space XSlope (%) | 2.5 | N/A | B 2 Clear Floor Space XSlope (%) | 2.7 |

Possible Solutions: Remove and Replace Clear Space.

Total Cost: \$ 378
