# Access Compliance Report Public Rights-of-Way (Pedestrian Signals)

Main Street: **CHIQUITA\_CANYON\_DR** Cross Street: **ESENCIA\_DR** Location: **NW**

ADA ID: **SGRK211124132457** Signal Type: **One Push Button-Non APS** Overall Compliance: **No** Severity Scores: **BTN 1: 35** **BTN 2: N/A** **No BTN: N/A**

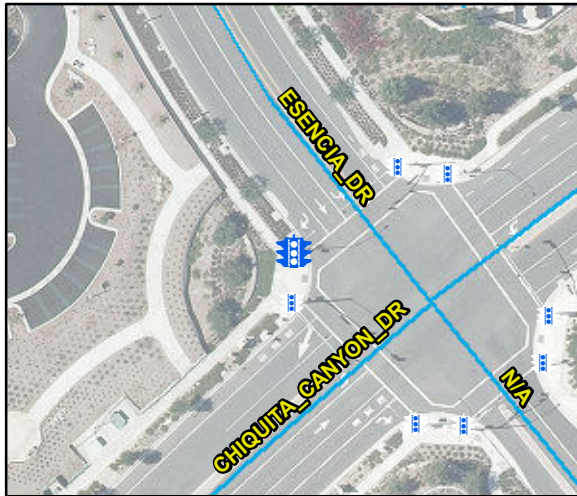
| Compliance | Description | Data | Compliance | Description | Data |
|---|---|---|---|---|---|
| <b>No</b> | B 1 Clear Floor Space XSlope (%) | <b>2.1</b> | <b>N/A</b> | B 2 Clear Floor Space XSlope (%) | <b>N/A</b> |
| <b>No</b> | B 1 DistanceTo XWalk (in) | <b>62</b> | <b>N/A</b> | B 2 DistanceTo XWalk (in) | <b>N/A</b> |

Possible Solutions: Replace Signal Push Button With APS Button. Remove & Relocate Sign.
