# Access Compliance Report Public Rights-of-Way (Pedestrian Signals)

Main Street: CHIQUITA\_CANYON\_DR Cross Street: ESENCIA\_DR Location: NW

ADA ID: SGRK211124132614 Signal Type: One Push Button-Non APS Overall Compliance: No Severity Scores: BTN 1: 35 BTN 2: N/A No BTN: N/A

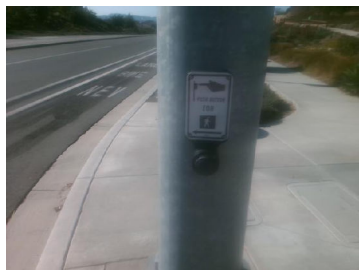
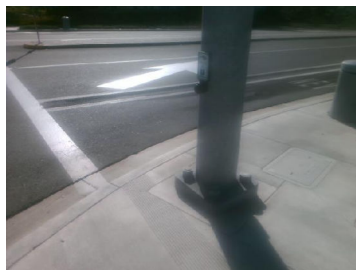
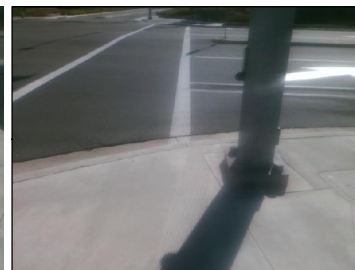
| No B 1 Pilot Light? | No | N/A B 2 Pilot Light? | N/A |

| Compliance | Description | Data | Compliance | Description | Data |
|---|---|---|---|---|---|
| No B 1 Clear Floor Space Slope (%) | 4.7 | N/A | B 2 Clear Floor Space Slope (%) | N/A | |
| No B 1 Clear Floor Space XSlope (%) | 9.8 | N/A | B 2 Clear Floor Space XSlope (%) | N/A | |

Possible Solutions: Replace Signal Push Button With APS Button. Remove and Replace Clear Space.

OC Std/PROW: R404.2, R404.3, MUTCD 4e.08
