# Access Compliance Report

## Public Rights-of-Way

Main Street: N/A Cross Street: CHIQUITA\_CANYON\_DR Location: SW

ADA ID: SGRK211124133003 Signal Type: One Push Button-Non APS Overall Compliance: No Severity Scores: BTN 1: 35 BTN 2: N/A No BTN: N/A

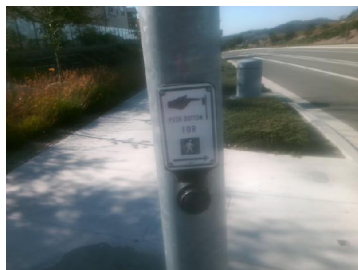
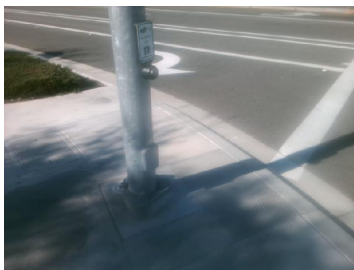
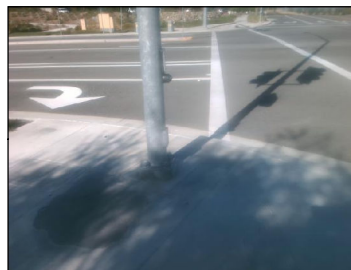
| No B 1 Pilot Light? | No | N/A B 2 Pilot Light? | N/A |

| Compliance | Description | Data | Compliance | Description | Data |
|---|---|---|---|---|---|
| No B 1 Clear Floor Space XSlope (%) | 5.3 | N/A | B 2 Clear Floor Space XSlope (%) | N/A | |

Possible Solutions: Replace Signal Push Button With APS Button. Remove and Replace Clear Space.

OC Std/PROW: R404.2, MUTCD 4e.08
