# Access Compliance Report Public Rights-of-Way (Pedestrian Signals)

Main Street: N/A Cross Street: CHIQUITA\_CANYON\_DR Location: SW

ADA ID: SGRK211124133114 Signal Type: One Push Button-Non APS Overall Compliance: No Severity Scores: BTN 1: 35 BTN 2: N/A No BTN: N/A

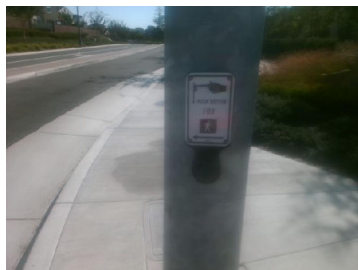
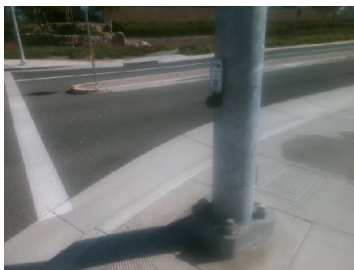
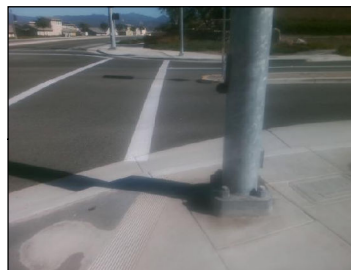
| No B 1 Pilot Light? | No | N/A B 2 Pilot Light? | N/A |

| Compliance | Description | Data | Compliance | Description | Data |
|---|---|---|---|---|---|
| No B 1 Clear Floor Space Slope (%) | 4.5 | N/A | B 2 Clear Floor Space Slope (%) | N/A | |
| No B 1 Clear Floor Space XSlope (%) | 4.2 | N/A | B 2 Clear Floor Space XSlope (%) | N/A | |

Possible Solutions: Replace Signal Push Button With APS Button. Remove and Replace Clear Space.

OC Std/PROW: R404.2, R404.3, MUTCD 4e.08

Total Cost: \$ 1278
