# Access Compliance Report Public Rights-of-Way (Pedestrian Signals)

Main Street: **CHIQUITA\_CANYON\_DR** Cross Street: **N/A** Location: **SE**

ADA ID: **SGRK211124133458** Signal Type: **One Push Button-Non APS** Overall Compliance: **No** Severity Scores: **BTN 1: 35** **BTN 2: N/A** **No BTN: N/A**

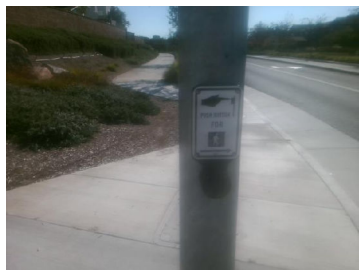
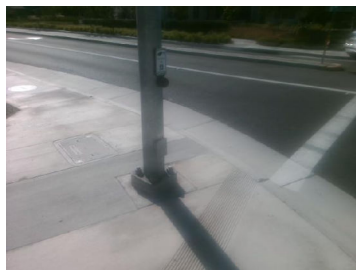
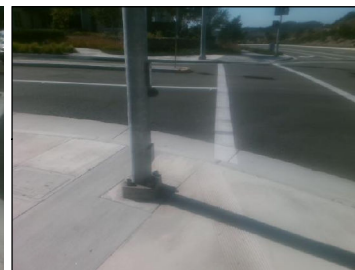
| <b>No</b> B 1 Pilot Light? | <b>No</b> | <b>N/A</b> B 2 Pilot Light? | <b>N/A</b> |

| Compliance | Description | Data | Compliance | Description | Data |
|---|---|---|---|---|---|
| <b>No</b> | B 1 Clear Floor Space XSlope (%) | <b>2.1</b> | <b>N/A</b> | B 2 Clear Floor Space XSlope (%) | <b>N/A</b> |

**Possible Solutions: Replace Signal Push Button With APS Button. Remove and Replace Clear Space.**

**OC Std/PROW: R404.2, MUTCD 4e.08**
