# Access Compliance Report Public Rights-of-Way (Pedestrian Signals)

Main Street: **CHIQUITA\_CANYON\_DR** Cross Street: **N/A** Location: **SE**

ADA ID: **SGRK211124133607** Signal Type: **One Push Button-Non APS** Overall Compliance: **No** Severity Scores: **BTN 1: 35** **BTN 2: N/A** **No BTN: N/A**

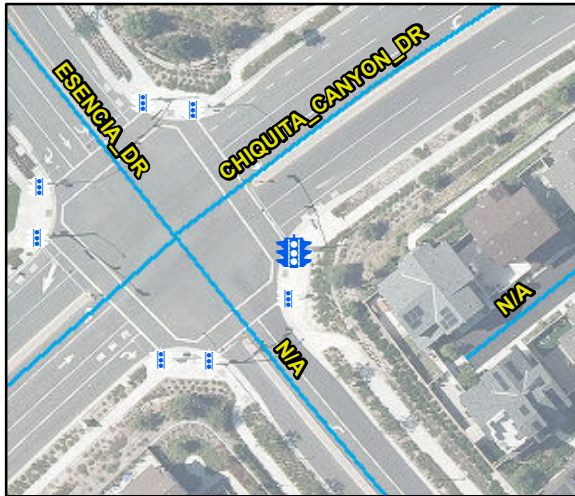
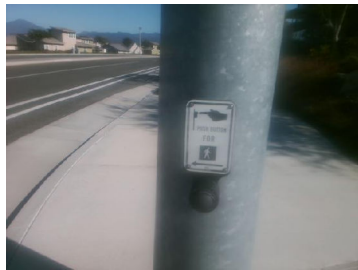
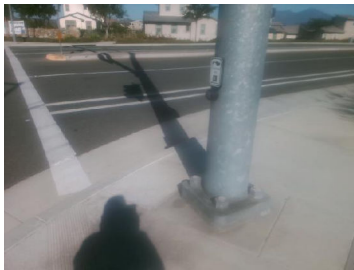
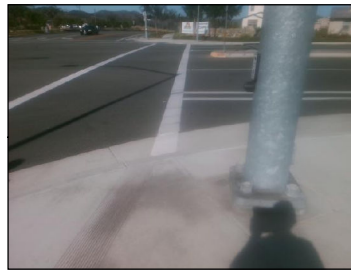
| <b>No</b> B 1 Pilot Light? | <b>No</b> | <b>N/A</b> B 2 Pilot Light? | <b>N/A</b> |

| Compliance | Description | Data | Compliance | Description | Data |
|---|---|---|---|---|---|
| <b>No</b> B 1 Clear Floor Space Slope (%) | | <b>3</b> | <b>N/A</b> | B 2 Clear Floor Space Slope (%) | <b>N/A</b> |
| <b>No</b> B 1 Clear Floor Space XSlope (%) | | <b>4.9</b> | <b>N/A</b> | B 2 Clear Floor Space XSlope (%) | <b>N/A</b> |

Possible Solutions: Replace Signal Push Button With APS Button. Remove and Replace Clear Space.

OC Std/PROW: **R404.2, R404.3, MUTCD 4e.08**

Total Cost: \$ **1278**
