# Access Compliance Report Public Rights-of-Way (Pedestrian Signals)

Main Street: **ESENCIA\_DR** Cross Street: **CHIQUITA\_CANYON\_DR** Location: **NE**

ADA ID: **SGRK211124133943** Signal Type: **One Push Button-Non APS** Overall Compliance: **No** Severity Scores: **BTN 1: 35** **BTN 2: N/A** **No BTN: N/A**

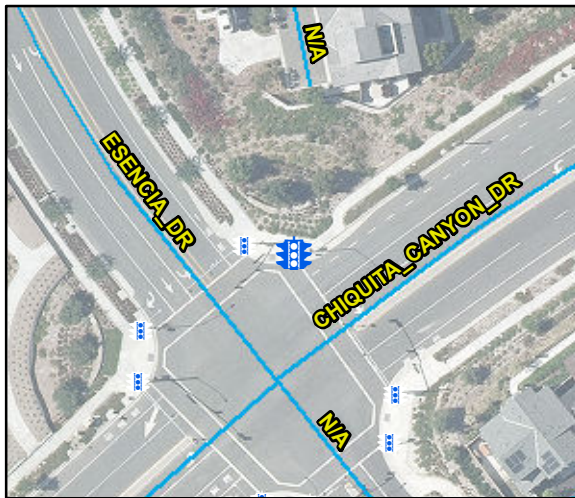
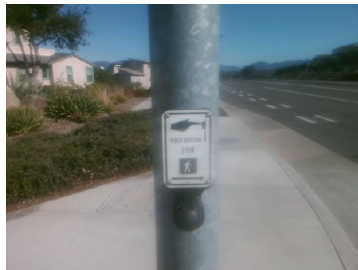
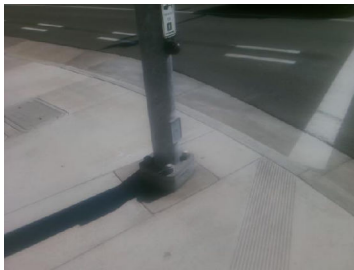
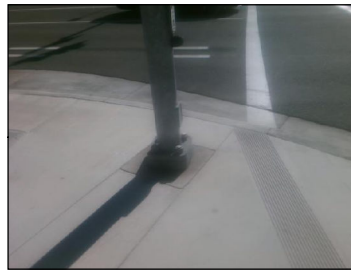
| Compliance | Description | Data | Compliance | Description | Data |
|---|---|---|---|---|---|
| <b>No</b> | B 1 Clear Floor Space Slope (%) | <b>2.8</b> | <b>N/A</b> | B 2 Clear Floor Space Slope (%) | <b>N/A</b> |

Possible Solutions: Replace Signal Push Button With APS Button. Remove and Replace Clear Space.

OC Std/PROW: **R404.2, R404.3, MUTCD 4e.08**
