# Access Compliance Report Public Rights-of-Way (Pedestrian Signals)

Main Street: COW\_CAMP\_RD Cross Street: COW\_CAMP\_RD Location: S

ADA ID: SGRK211129120331 Signal Type: One Push Button-Non APS Overall Compliance: No Severity Scores: BTN 1: 50 BTN 2: N/A No BTN: N/A

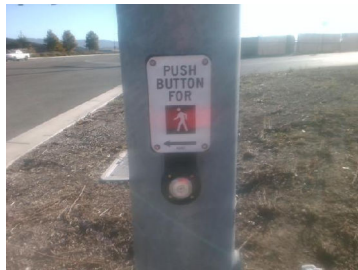
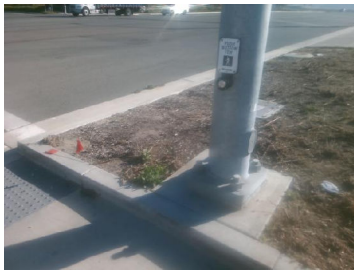
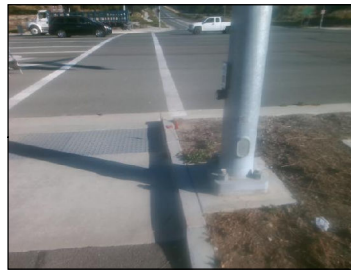
| Compliance | Description | Data | Compliance | Description | Data |
|---|---|---|---|---|---|
| No | B 1 PARA Approach Reach (in) | 16 | N/A | B 2 PARA Approach Reach (in) | N/A |
| No | B 1 Clear Floor Space Slope (%) | 9.4 | N/A | B 2 Clear Floor Space Slope (%) | N/A |
| No | B 1 Clear Floor Space XSlope (%) | 12.8 | N/A | B 2 Clear Floor Space XSlope (%) | N/A |
| No | B 1 DistanceTo Curb (in) | 89 | N/A | B 2 DistanceTo Curb (in) | N/A |

Possible Solutions: Replace Signal Push Button With APS Button. Remove & Relocate Sign. Provide Push Button Extension.
